REPORT ON CAUSES AND REMEDIAL MEASURES
WAIOMAO SLIDE, HONOLULU

GREGG M. SINCLAIR
UNIVERSITY OF HAWAII

Ralph B. Peck
December 1959

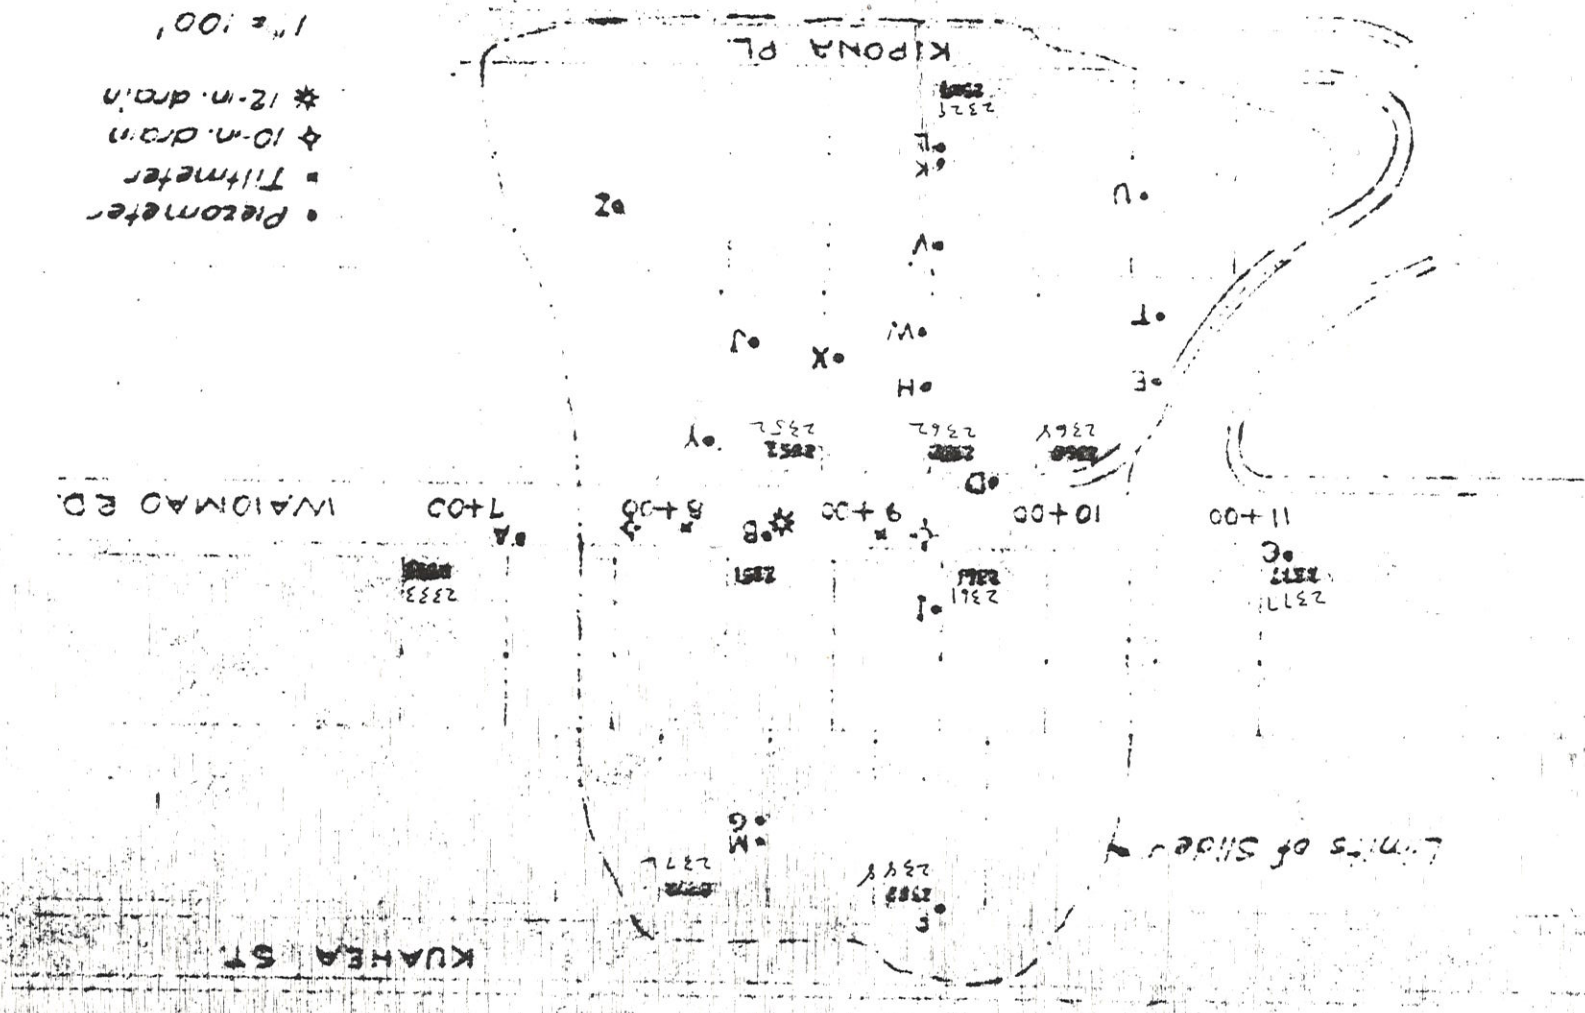
KEY PLAN
FIG. 2

A key plan of the slide area is shown in Fig. 2. At the location of each of the piezometers shown in this figure, as well as at the location of the drains and tiltmeters, information was obtained by test boring techniques regarding the character of the soils. Drilling through the materials was found to be difficult, and sampling almost impossible. The difficulties were a consequence of the presence of large numbers of rock fragments, some of considerable size. The materials encountered in the borings and disclosed by the samples are generally described as clay with boulders. Inspection of exposures in the locality combined with a study of the boring logs indicates that the material involved in the slide and adjacent to it consists of a mixture of basalt talus from the steep sides of the valley, weathered basalt of the consistency of clay, and some materials of intermediate sizes. At least the upper part of the slide probably consists of fill discarded from the quarry. However, this fill appears to consist essentially of the same constituents as those present in the weathered natural soils and it is not possible on the basis of the borings to determine a line of demarkation between the debris wasted from the quarry and the

The outline of the sliding area is shown in plan in Fig. 2. Three cross sections through the slide showing conditions at approximately Stas. 10+40, 9+30, and 8+50 (Walomao Road stationing) are shown in Fig. 3. In these sections the position of the surface of sliding is indicated.

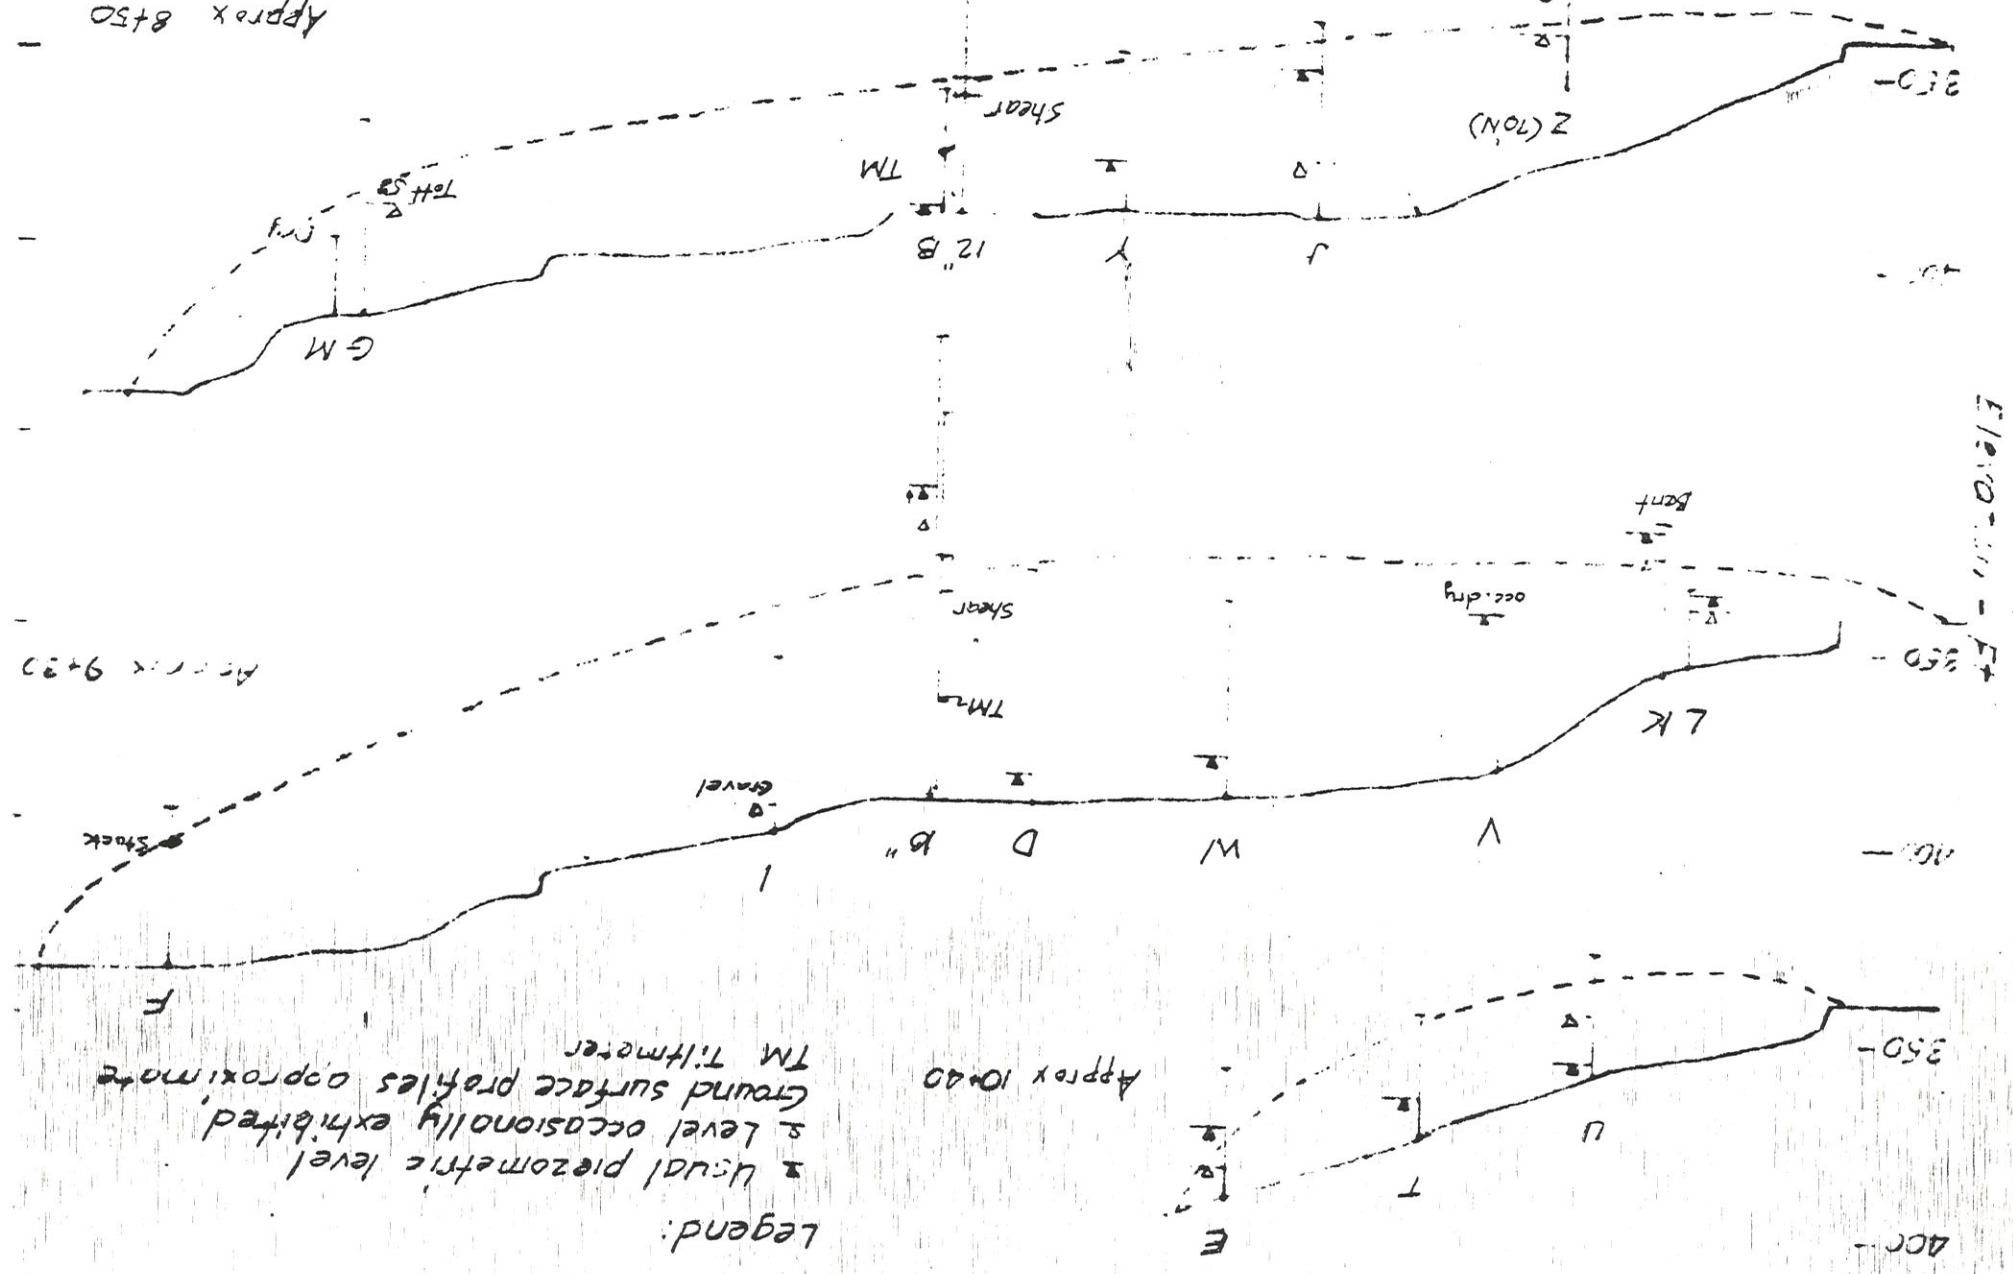
CONDENSED PIEZOMETRIC OBSERVATION
Approx 8+50
FIG. 3

The location of the surface of sliding has been determined on the basis of observations of the position of the escarpment at the upper end of the slide, of the bulge at the lower end of the slide, and by the results of the tiltmeter observations. In addition to these primary data, supplementary information has been obtained by noting elevations at which various piezometers became bent to the extent that sounding devices could not be lowered in them. The data establish that the maximum depth of the slide is roughly 60 ft below the surface at Walomao Road. Thus, the slide would be classified as relatively deep. It is significant that the surface of sliding is located within the

the movement is almost exclusively horizontal. At the bottom of the slide at Kipona Place, the movement is primarily horizontal but with a substantial upward component. These motions are compatible with the shape of the surface of sliding indicated in Fig. 3.

Most of the piezometers established in the slide area consist of pipes perforated throughout their length. The water levels in the pipes should, therefore, represent the elevations of the free water surface corresponding to the most pervious zones of material traversed by the piezometers. The variations in piezometric elevation at the locations are shown as a function of time in Figs. 6 and 7. Some of the piezometers appear to be relatively stable and virtually unaffected by periods of intense rainfall. Others are quite sensitive to rainfall and show abrupt rises in water level in a rainy period followed by relatively rapid reduction to a more normal value. The usual water levels displayed by the piezometers in recent months are shown in Fig. 3 on the three cross sections previously discussed. If a piezometer indicates rather frequently higher or lower values than the usual values, the extreme indications are shown by open triangles whereas the solid triangles represent the usual positions.

It may be observed that, as a very rough statement, the water levels in the upper and the lower parts of the slide are relatively low compared to the position of the surface of sliding, but those near Waiomao Road are rather high. The erratic distribution of piezometric levels signifies the presence of pockets of relatively pervious material separated from other pockets by virtually impervious barriers.

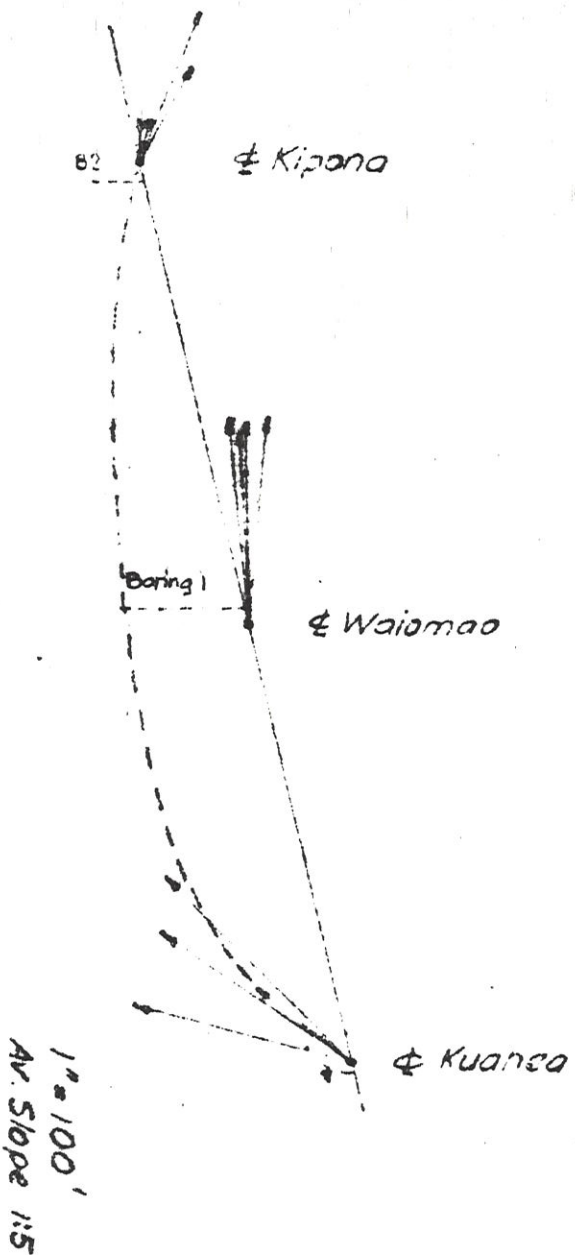
FIG. 4

Vertical and horizontal displacements have been measured periodically since 25 September 1957 at several cross sections on each of the three streets in the subdivision. The results are contained in drawings prepared by the City. They are summarized in the sketch, Fig. 4, for the period between April and June 1958. The sketch demonstrates that the movement at Kuahaea Street is largely downward with a horizontal component smaller than the vertical component. At the center line of Waiomao Road

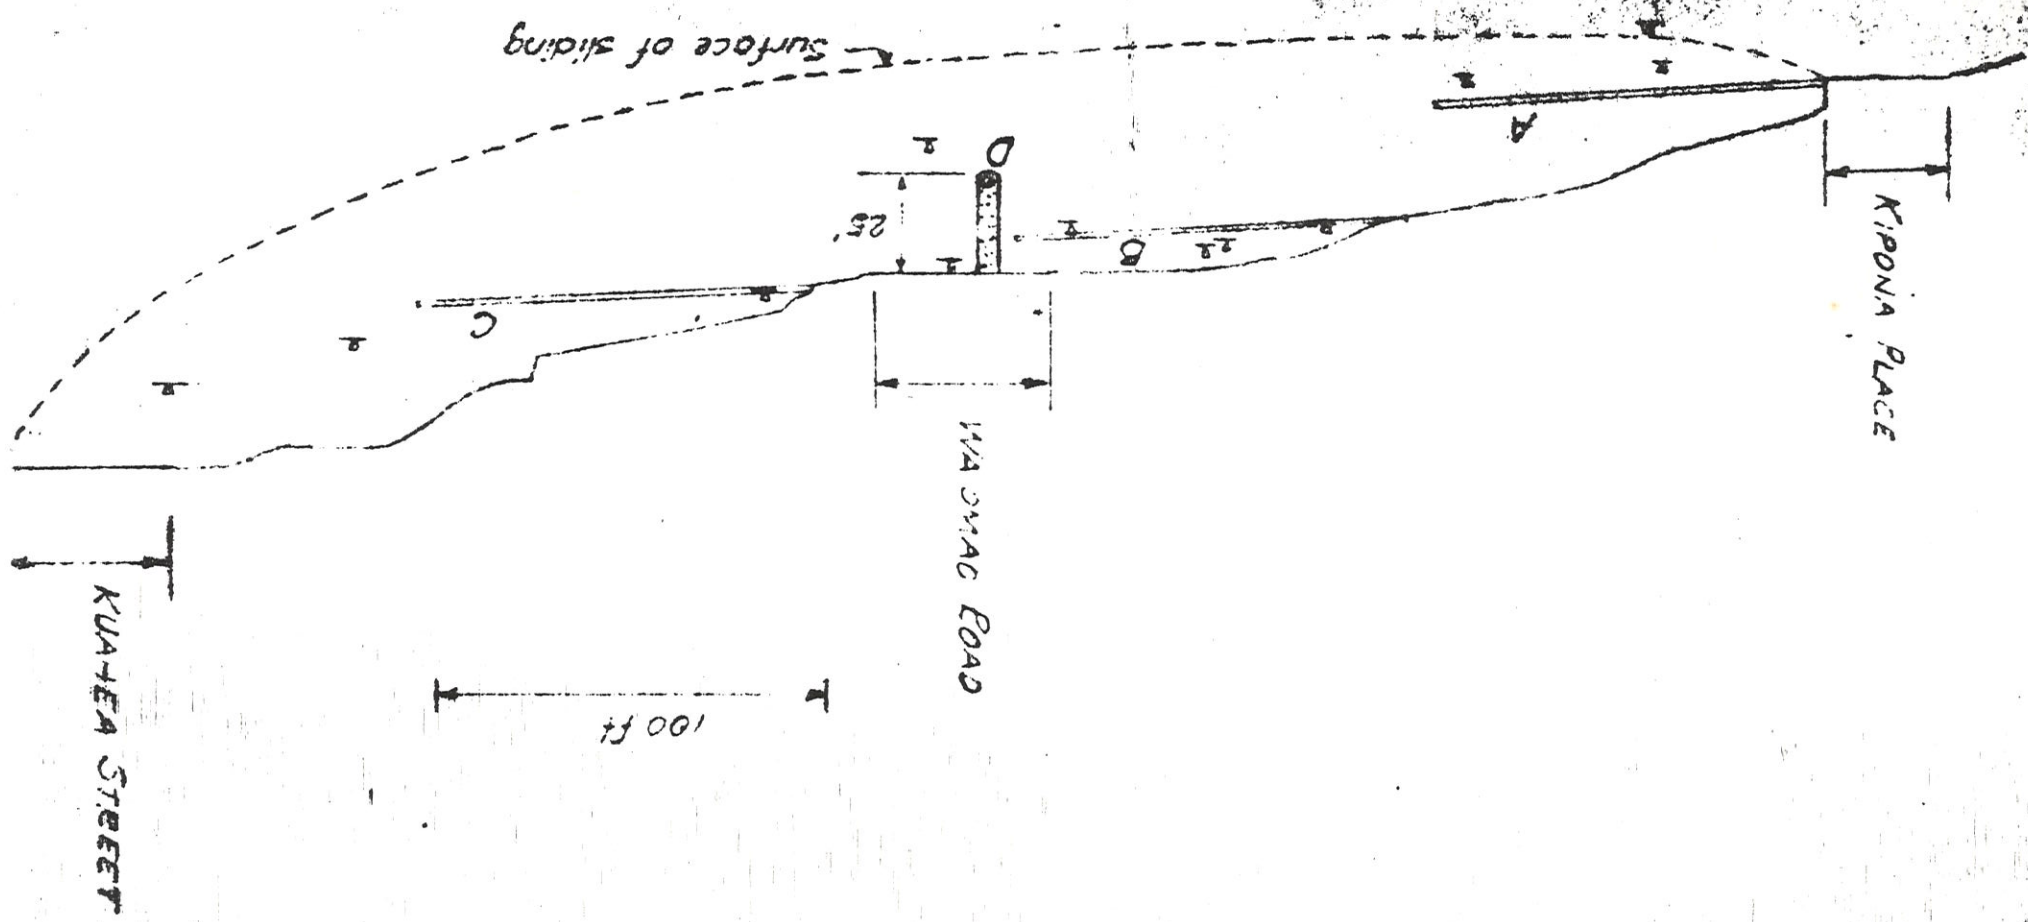
COMPARISON OF HORIZONTAL AND
TRENCH DRAINS
FIG. 8

The necessity for drains of considerable length is shown in the cross section, Fig. 8. Since the drains must be installed at a slightly upward angle, it is apparent that the ends of drains even as long as 100 ft will not be located at great depth below the ground surface and will hardly be able to lower the water table to a depth of more than 10 or 15 ft below the present surface. In particular, the relatively flat topography of the slide near Waiomao Road itself indicates that horizontal

Drains cannot lower the water table effectively to a point much below the present water table in many of the piezometers. In the upper and lower portions of the slide near Kusha Street and Kipona Place the water tables already appear to be lower than the level that could effectively be reached by horizontal drains.
